Exploratory Aircraft Ground Icing Research for the 2001-02 Winter

**Civil Aviation
Safety and Security
Transport Canada**

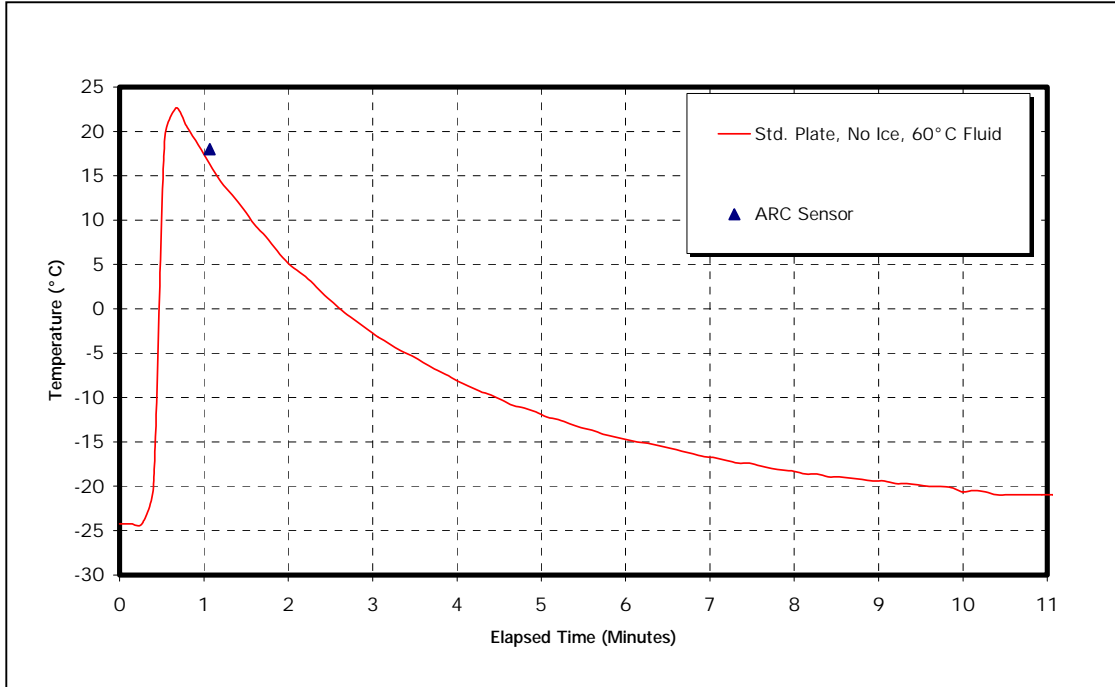
Figure 4.1: HOT Plate Temperature Profiles, Run 2
Type I Fluid, No Ice, OAT -23.6°C

Test results were obtained from visual observations and from the analysis of hard data. The results were very encouraging. As observed on the charts (see Figures 4.1 to 4.4), the readings from the sensors and the actual plate temperature were generally similar. The tests demonstrated that at a fixed position, all sensors, thermistors, and the hand-held thermometer were showing very close to equivalent readings. Furthermore, the infrared camera gave a very colourful representation of the plate during spraying.

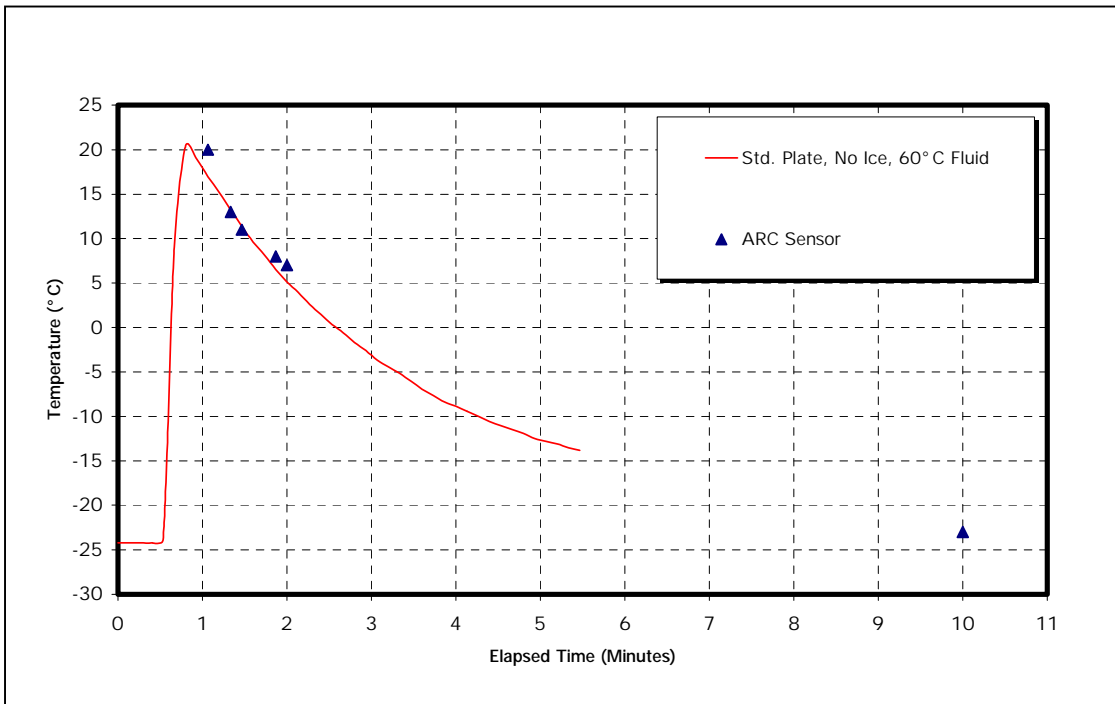
Figure 4.2: HOT Plate Temperature Profiles, Run 2a
Type I Fluid, No Ice, OAT -23.6°C

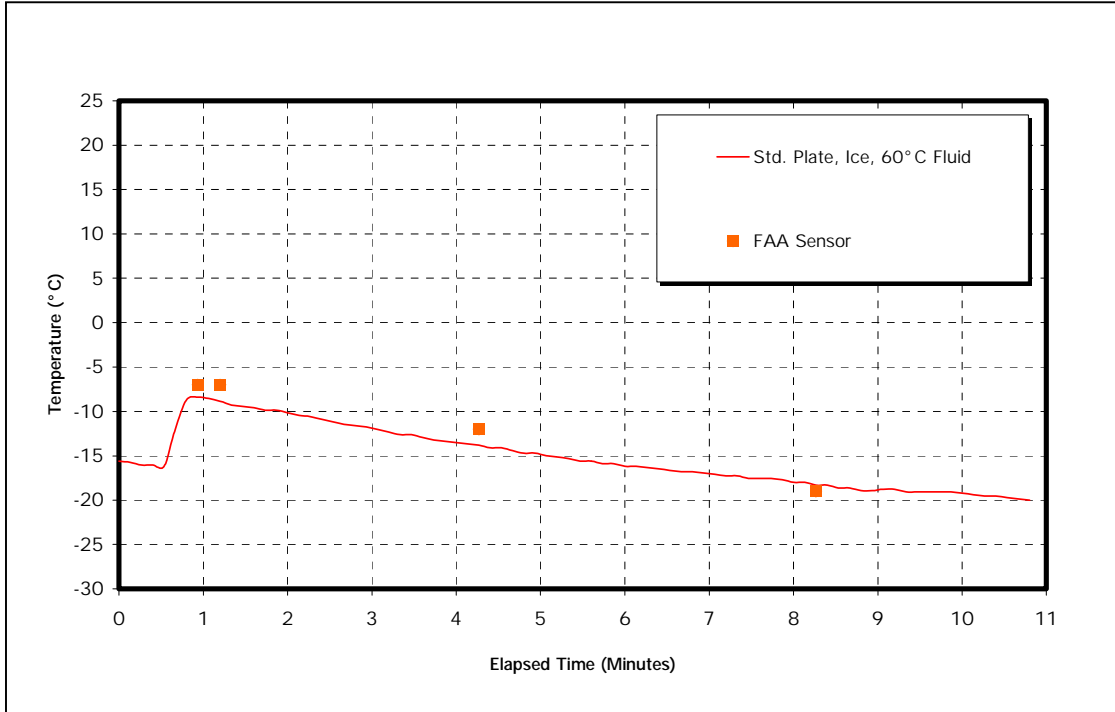
Figure 4.3: HOT Plate Temperature Profiles, Run 4
Type I Fluid, Plate Covered in Ice, OAT -23.9°C

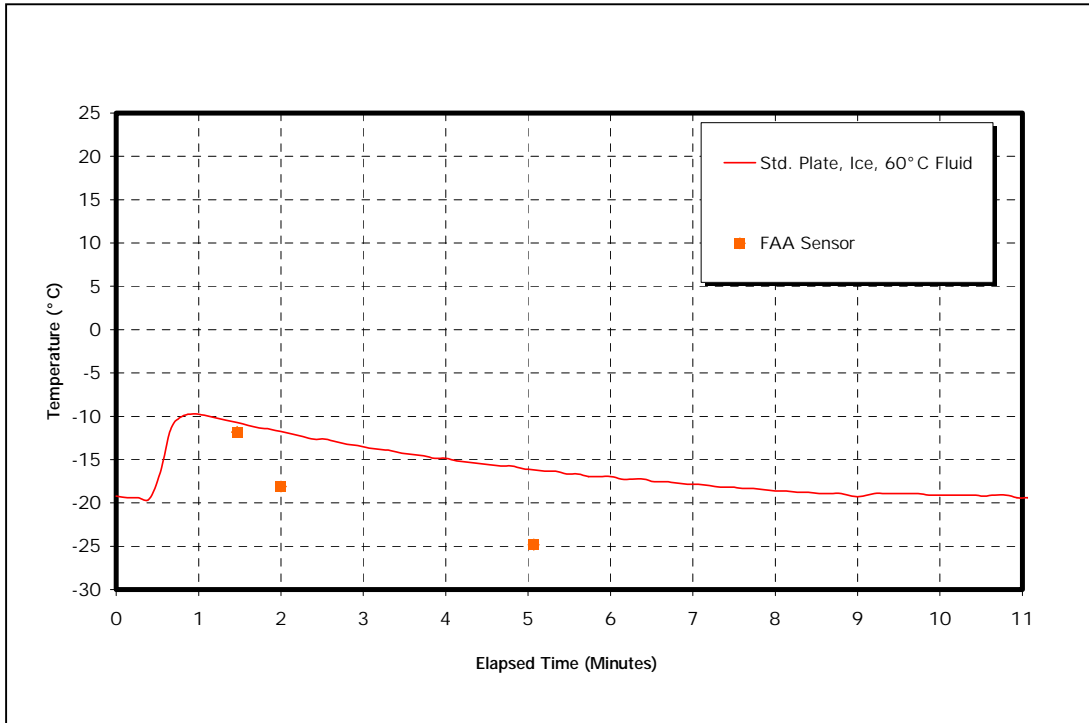
Figure 4.4: HOT Plate Temperature Profiles, Run 4a
Type I Fluid, Plate Covered in Ice, OAT -23.9°C

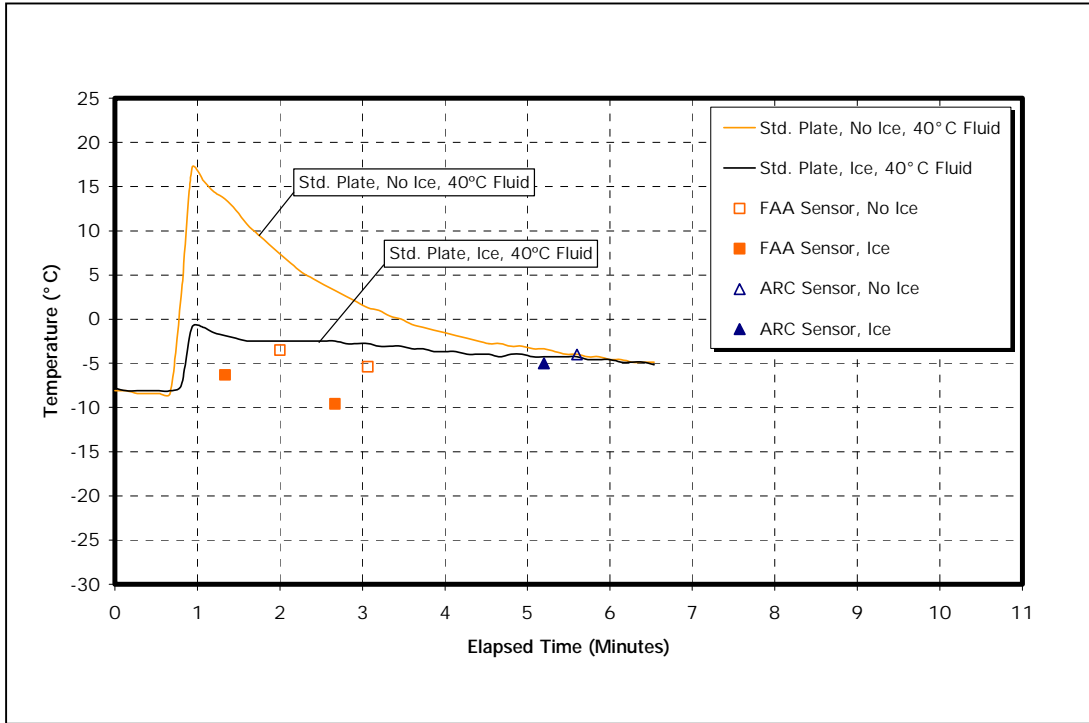
Figure 4.5: HOT Plate Temperature Profiles, Run 6
Type I Fluid, Half Plate Covered in Ice, OAT -10°C

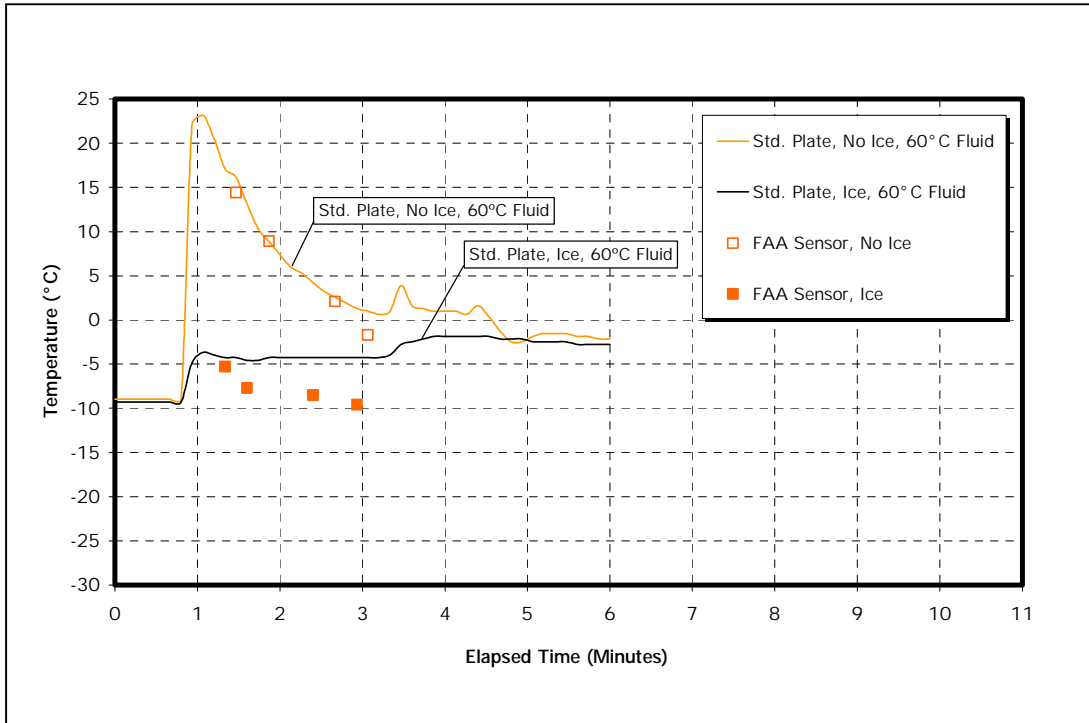
Figure 4.6: HOT Plate Temperature Profiles, Run 6a
Type I Fluid, Half Plate Covered in Ice, OAT -10°C

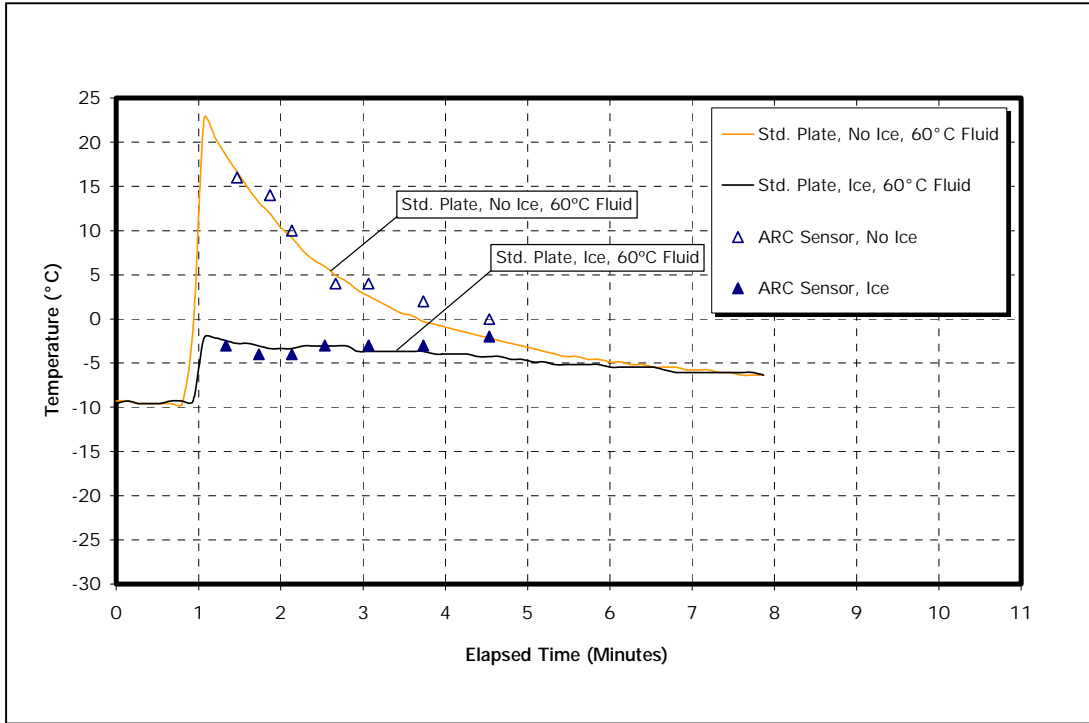
Figure 4.7: HOT Plate Temperature Profiles, Run 6b
Type I Fluid, Half Plate Covered in Ice, OAT -10°C

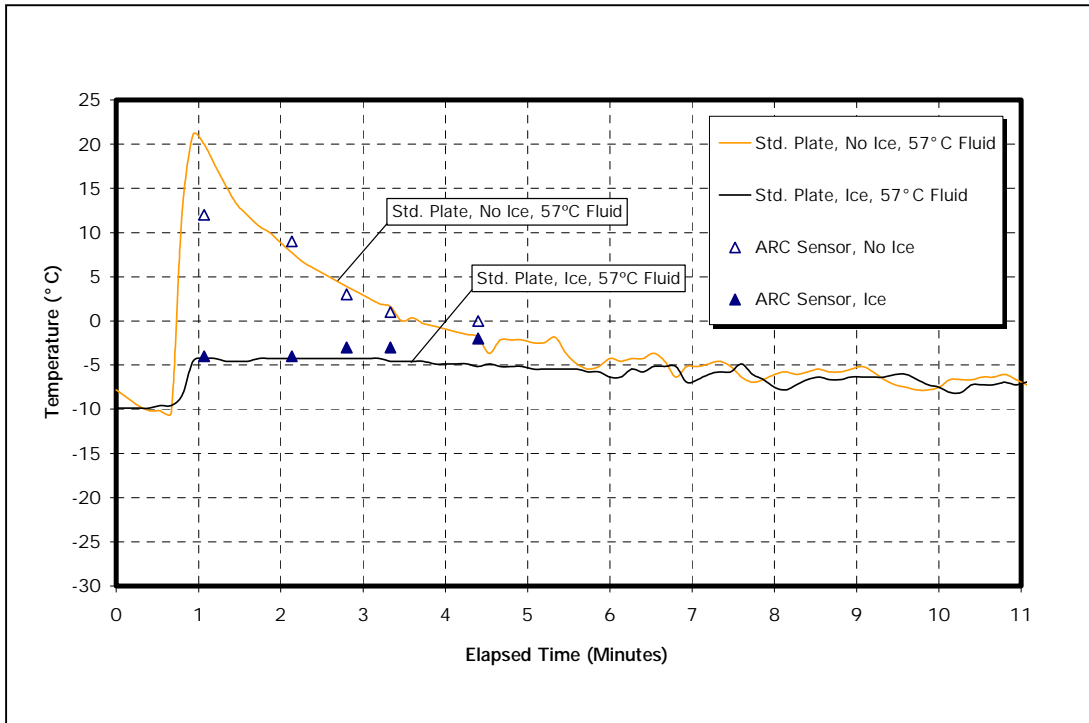
Figure 4.8: HOT Plate Temperature Profiles, Run 6c
Type I Fluid, Half Plate Covered in Ice, OAT -10°C
